Silo Condition Inspection Report

Silo Ridge Golf Course
Amenia, NY

RENNIA ENGINEERING DESIGN, PLLC
CIVIL & ENVIRONMENTAL ENGINEERING

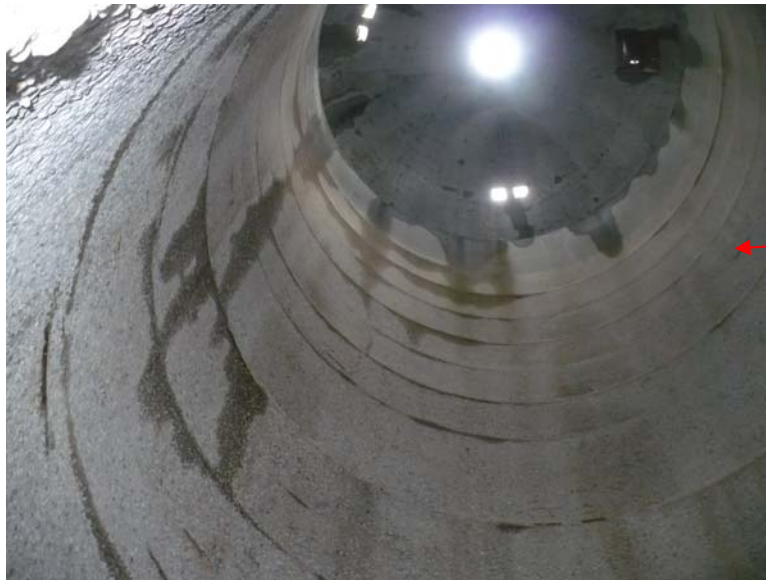
Silo Interior Upper Section

The interior portion of the roof appears to be in good condition as well with no cracking, spalling, or deterioration.

NO
SPALLING

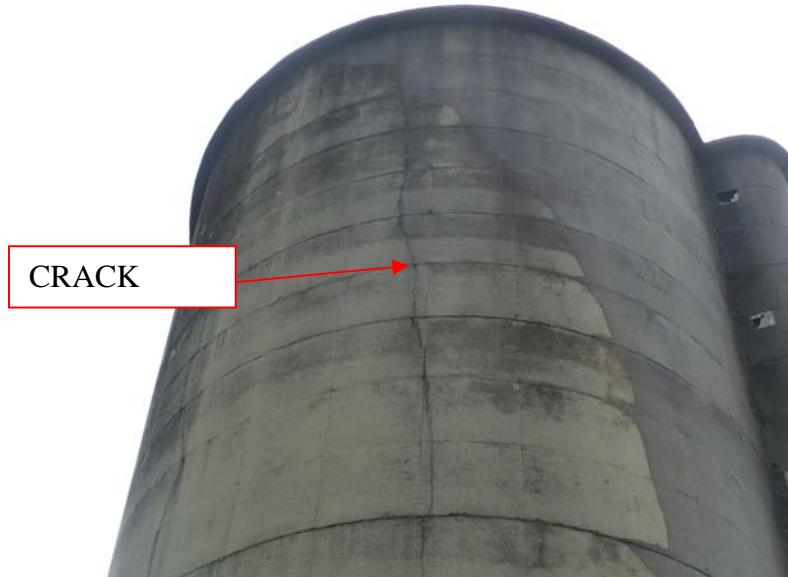
Silo Exterior

The exteriors of the silos were also found to be in good overall condition. Some minor cracking on the exterior of the silos is visible. The cracks appear to be stable and have not moved in many years.

The exterior foundation zone appears to be in good condition as well with no visible cracking or settlement. Additionally the area appears to be well drained.

The crack repair should include at minimum the following:

1. Remove any loose material with a high pressure water spray.
2. Router out the crack to 1/4" x 1/4".
3. Apply a concrete caulk such as Sikaflex 15 LM.

In addition to the above repairs we also recommend the cleaning of the exterior walls and application of a masonry water proofing compound such as Sure Klean Weather Seal Siloxane PD.
