3.1 Soils and Geology

3.1.1 Existing Conditions

Silo Ridge Resort Community

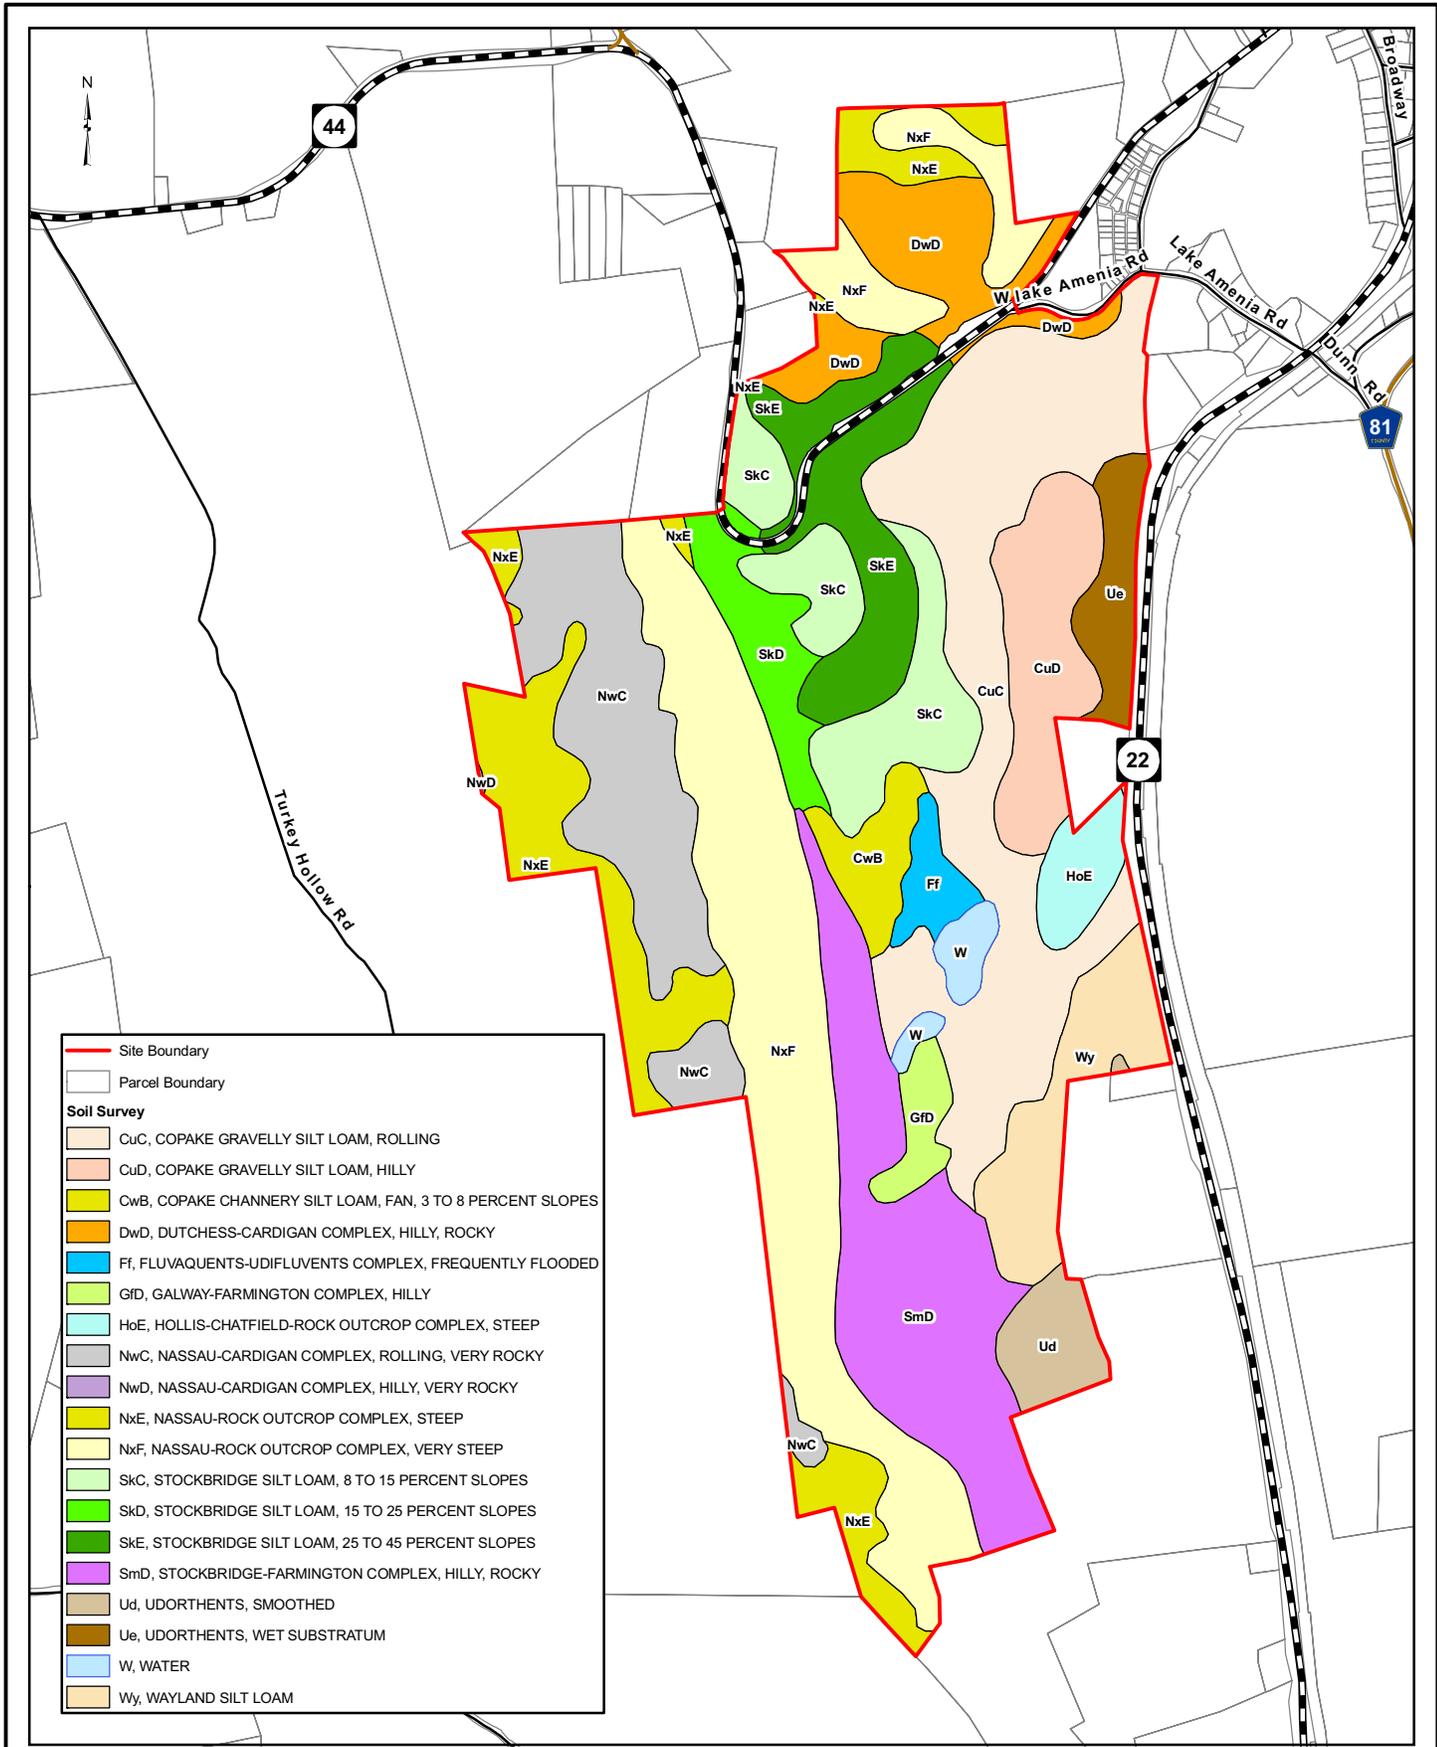
Figure 3.1-1

Soils Map

According to the United States Department of Agriculture (USDA) Dutchess County Soil Survey¹⁶ for this site, 17 soil types are identified on the 670±-acre project site, as illustrated on Figure 3.1-1, "Soils Map." The following offers the location and a detailed description of the various soil classifications identified for this site.

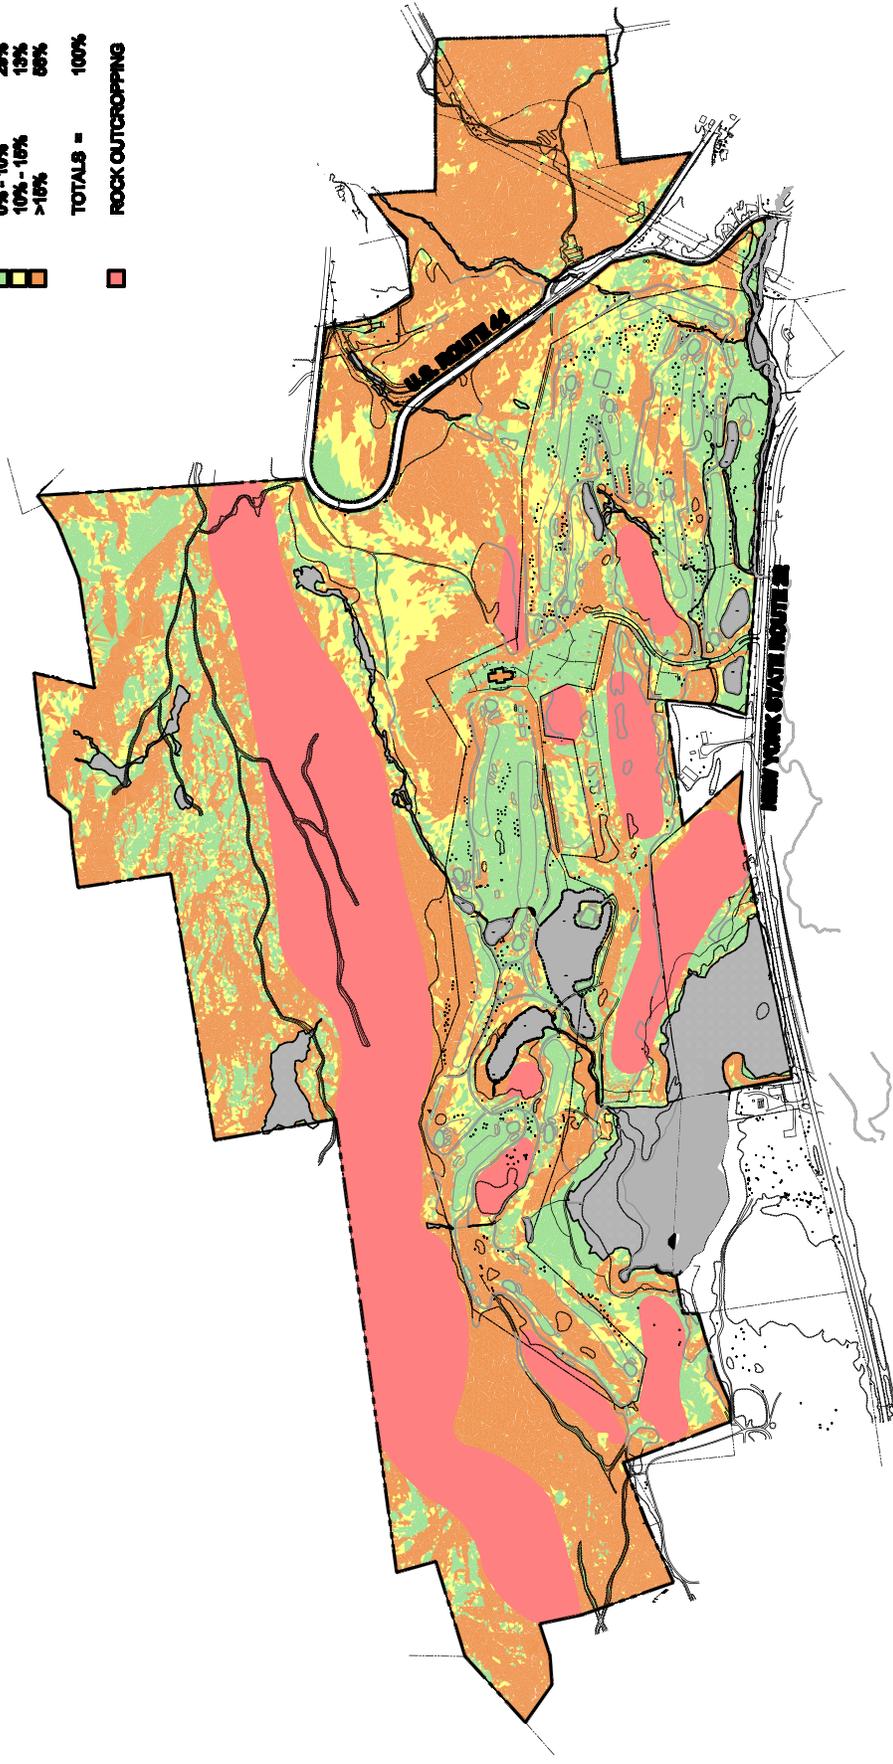
Figure
3.1-2

COLOR	SLOPE RANGE	PERCENTAGE	AREA
Light Green	0% - 10%	20%	199 Ac.
Yellow	10% - 15%	13%	88 Ac.
Orange	>15%	66%	389 Ac.
TOTALS =			100%
Red	ROCK OUTCROPPING		670 Ac.

Silo Ridge Resort Community
EXISTING SLOPE MAP
 Town of Armonk, Dutchess County, New York

Areas of rock outcrop can be found in the western portion of the project site along the hillsides and ridge. Slopes are varied over the project site, as shown on Figure 3.1-2, "Existing Slopes Map." Approximately 29% of the site has slopes that range from 0% to 10%; 13% of the site has slopes ranging from 10% to 15%; and 58% has slopes greater than 15%. The majority of the steeply sloped areas are located in the western portion of the site in association with the ridge.

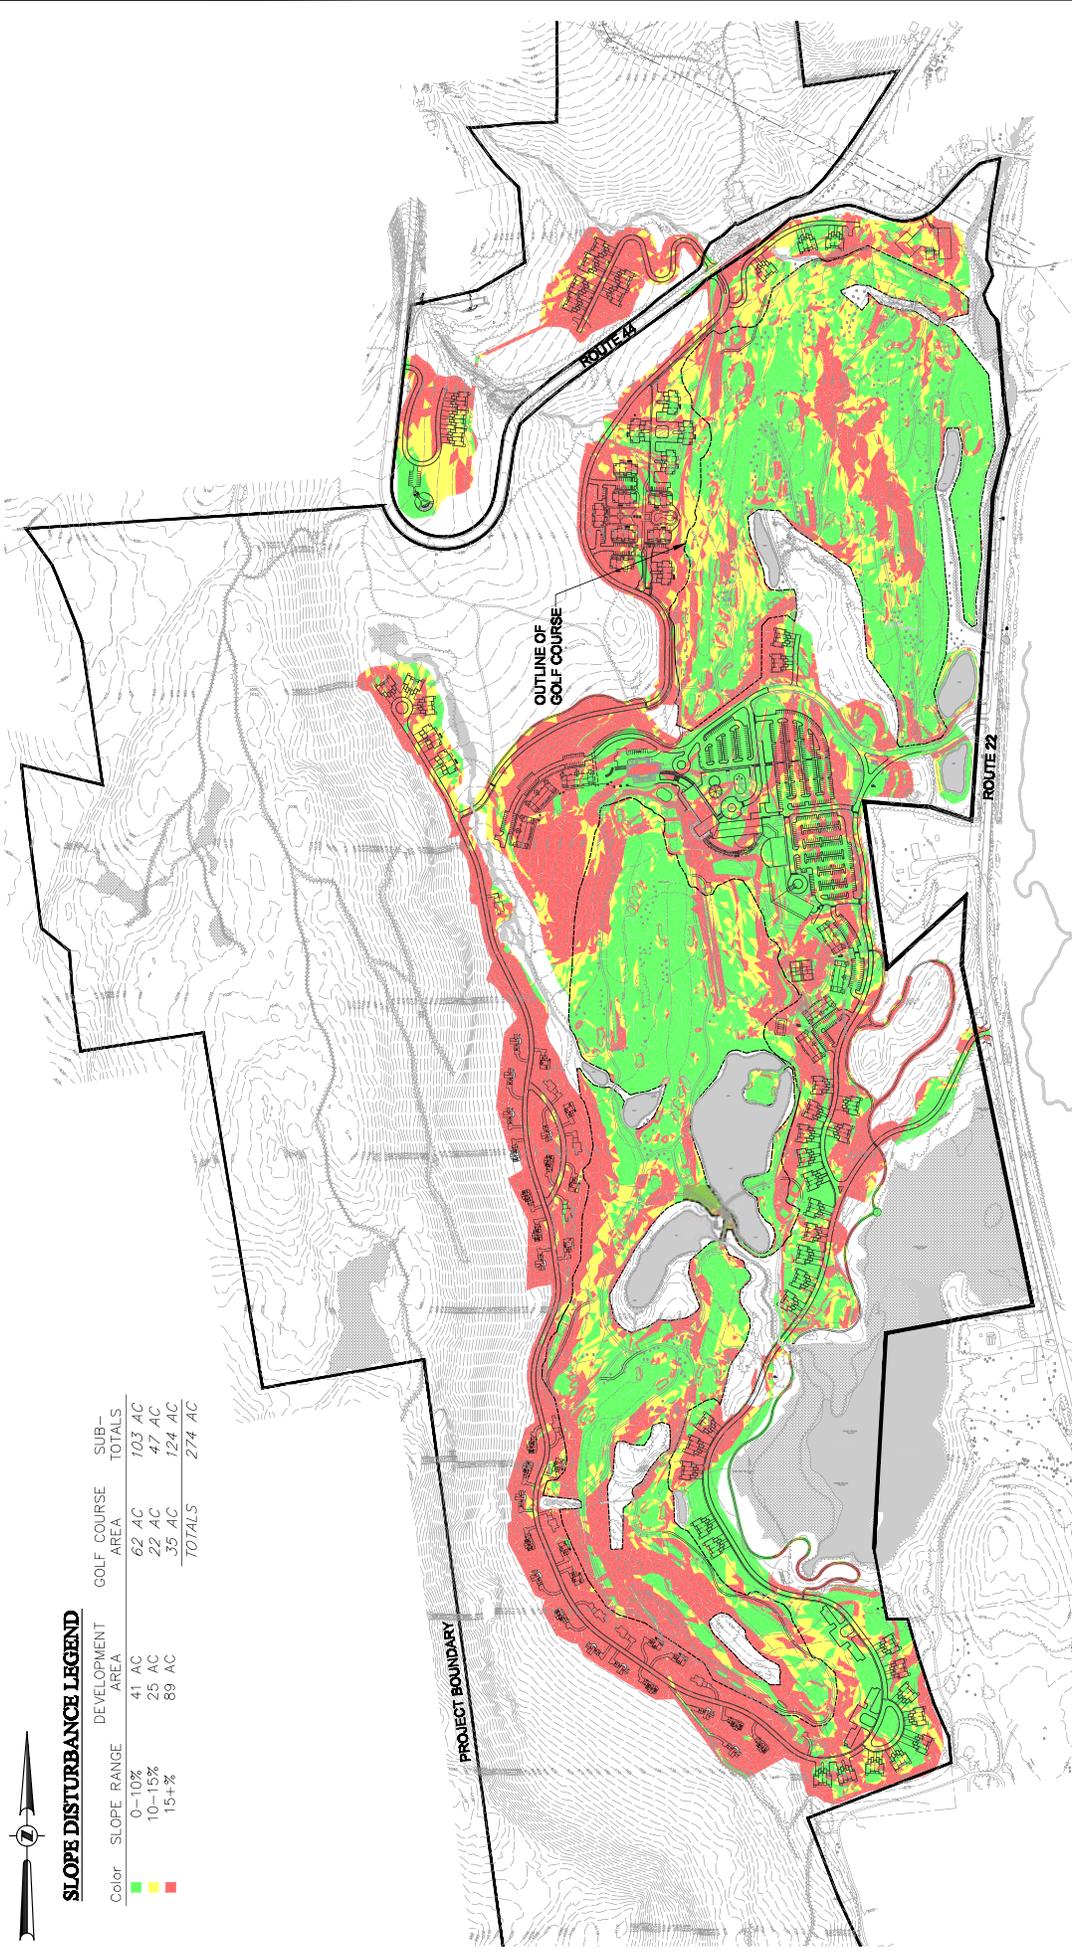
Figure 3.1-3

Color	SLOPE RANGE	DEVELOPMENT AREA	GOLF COURSE AREA	SUB-TOTALS
Green	0-10%	41 AC	62 AC	103 AC
Yellow	10-15%	25 AC	22 AC	47 AC
Red	15+%	89 AC	35 AC	124 AC
		TOTALS	TOTALS	274 AC

Silo Ridge Resort Community
Proposed Action
SLOPE DISTURBANCE MAP
Town of Arneria, Dutchess County, New York

As noted, the proposed project will disturb approximately 274 acres of the site. Table 3.1-3 summarizes the anticipated amount of disturbance by slope category, which includes disturbance resulting from both modification of the golf course and construction of the resort development. The amount of slope disturbance is shown graphically in Figure 3.1-3.
